HISTORIC SITE SUMMARY SHEET

Building Name: St. Barnabas at Oxon Hill

Location: 5203 St. Barnabas Road, Oxon Hill

Maryland Historical Trust State Historic Sites Inventory Form

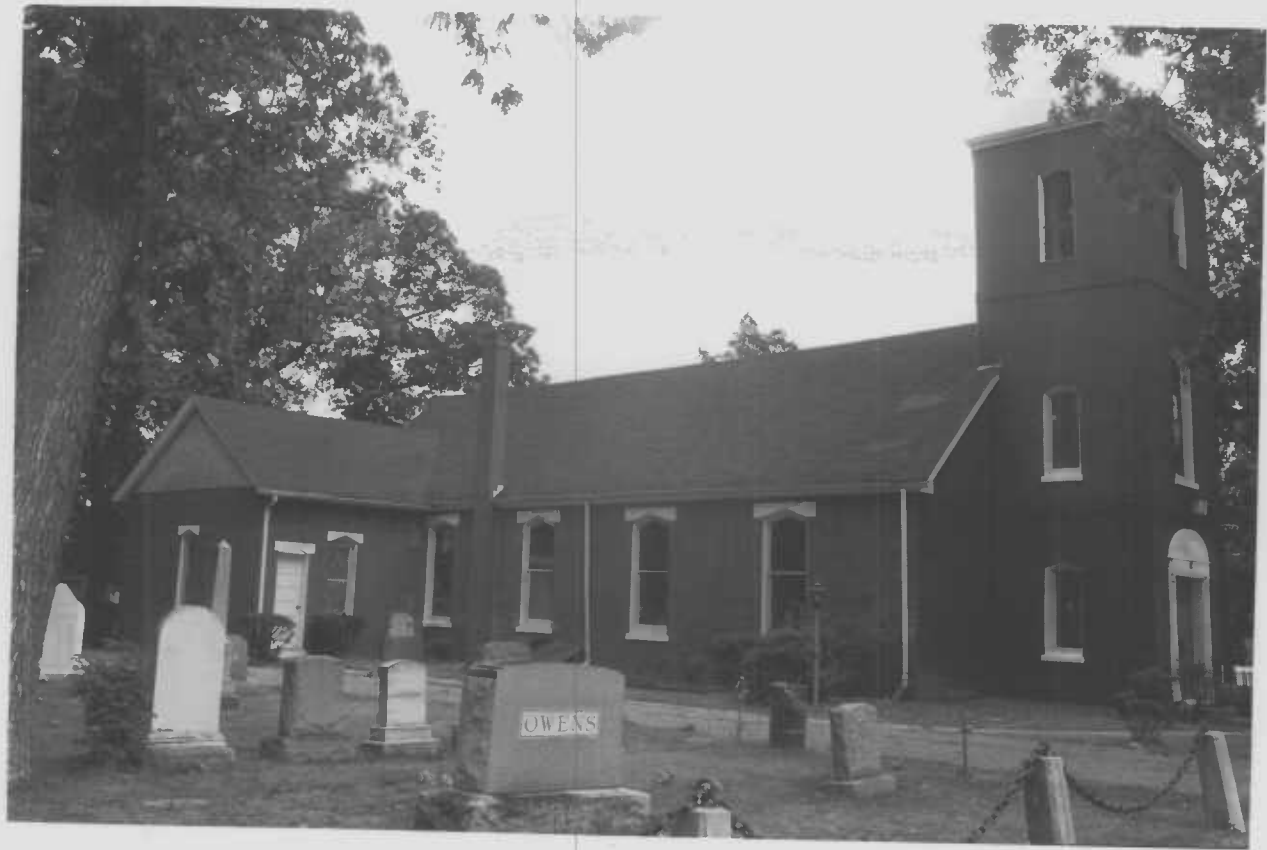
SW
P.G. #76A-4

St. Barnabas Church, Oxon Hill
Prince George's County, MD
Marina King
July 1987
Southwest elevation
Neg: MD Historical Trust, Annapolis, MD

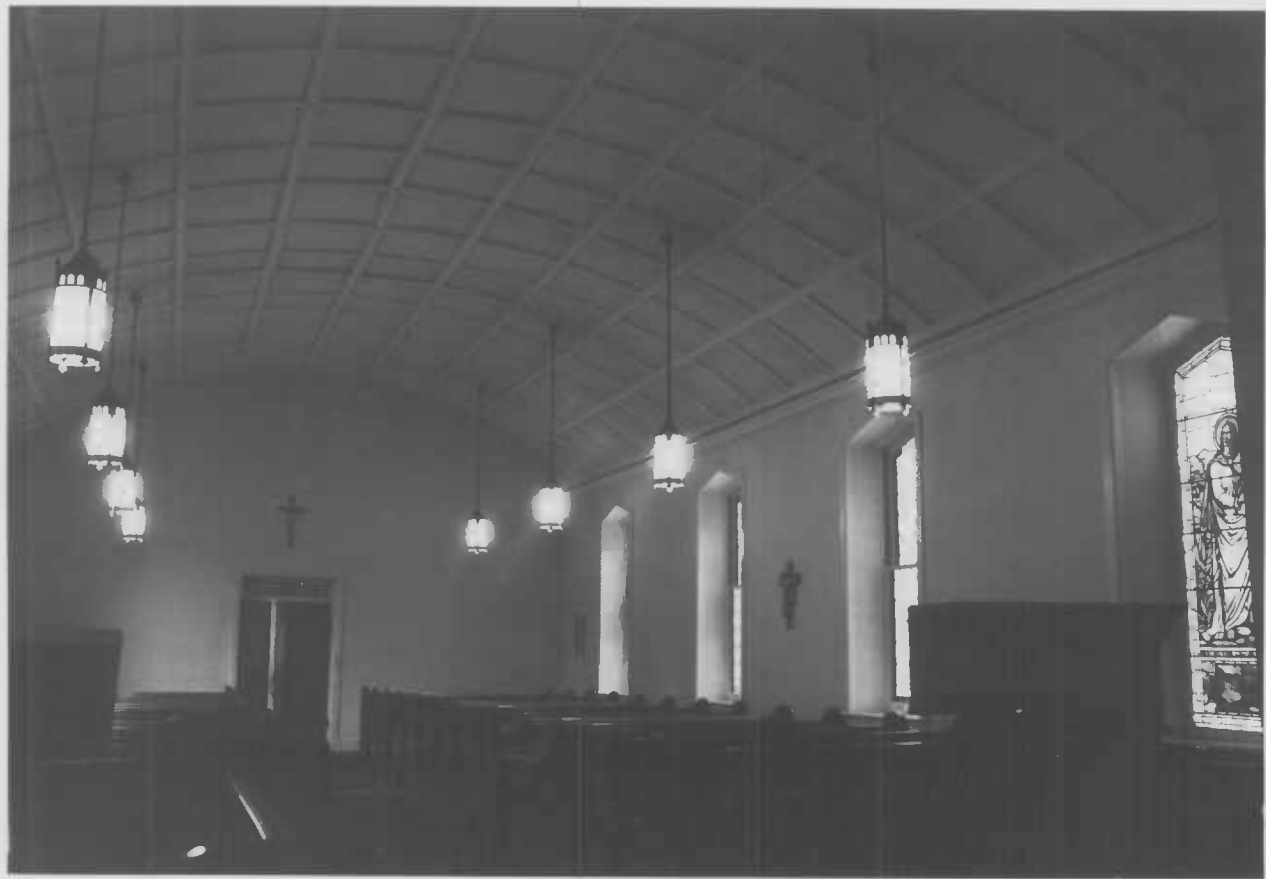
Sanctuary, looking south

The church interior is a rectangular open space lighted by the stained glass windows. Door and window surrounds are of wide, plain board. The flooring and pews lining both sides of the central aisle appear to be new material. The ceiling is a barrel vault with wood ribbing forming square coves over its surface. An elaborately molded cornice runs down the north and south sides of the room. A wide segmental arch provides entry to the sanctuary at the east end of the room. A matching arch provides entry into the circular apse beyond the sanctuary. The arches are supported by banded pilasters with dentiled capitals. The arches have banded wood molding and a central keystone. Round arch double doors flank the entry to the sanctuary. These lead to the small north and south wing additions. Lower segmental arched entries north and south of the central altar platform also lead to the side wings, the north wing being a choir and organ alcove. These lower arches are supported by flat pilasters with dentiled capitals and are surmounted by a keystone.
